Eibach Pro-Alignment Camber Adjustment Camber Bolts (94-04 All)

After installing a set of lowering springs in your Mustang, you will notice that your front wheels have a few degrees of negative camber (leaning inward), and if left uncorrected, can cause accelerated wear on one side of your front tires. This can be easily corrected with Eibach's adjustable camber bolts.

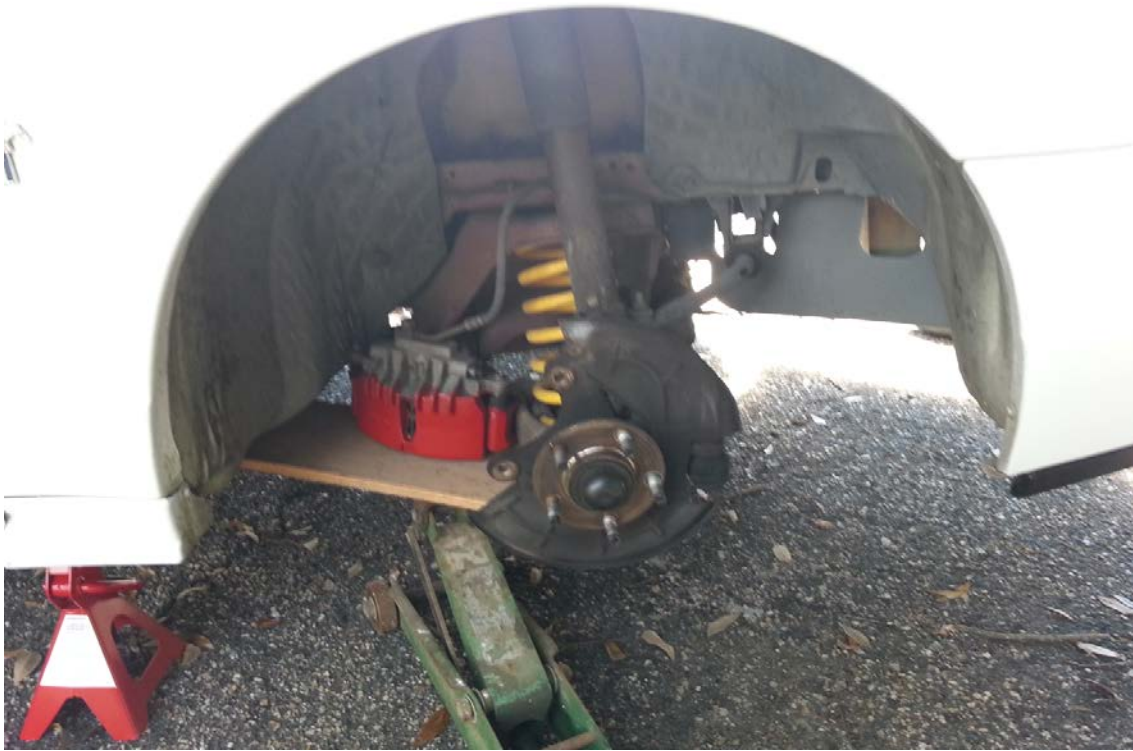
1. Get the front end of the car into the air, and place jack stands under the pinch rail.
2. Once the wheel is removed, remove the two bolts on the rear of the caliper that hold it to the spindle, and place the caliper and brake rotor out of your way. (I used a floor jack with a piece of wood as a shelf to sit the caliper on.)

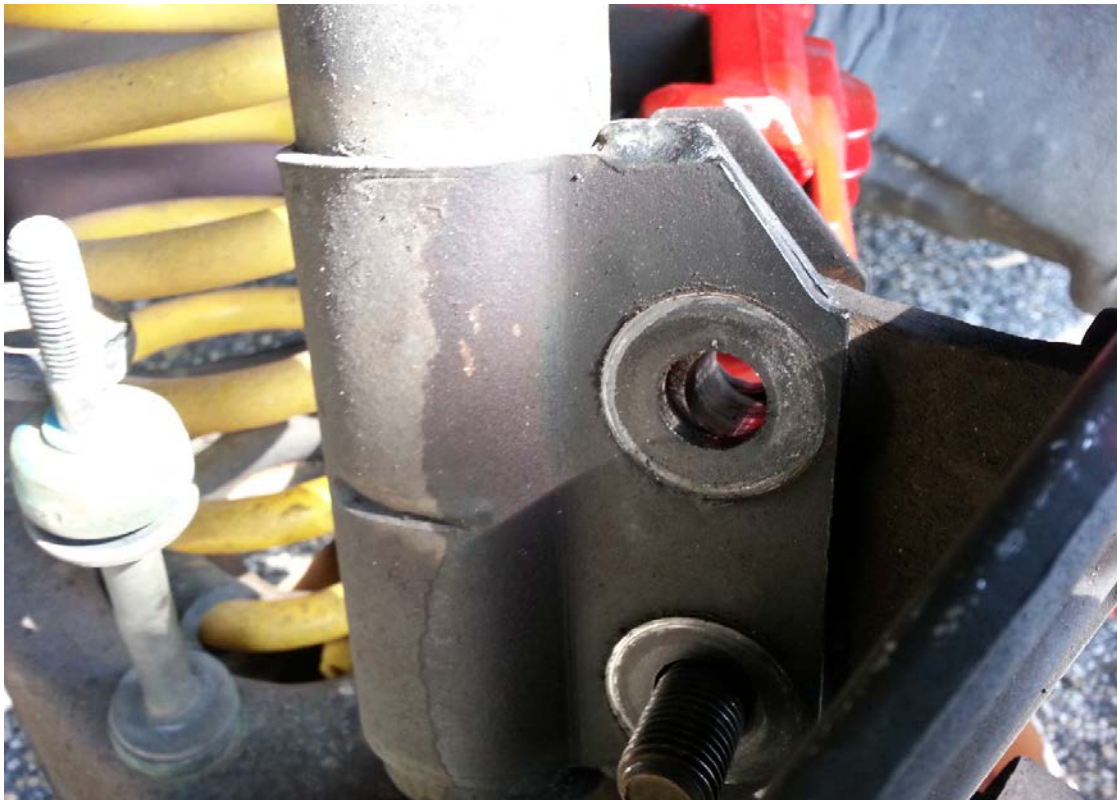
3. Remove the top bolt that holds the strut to the spindle, and loosen or remove the nut from the bottom one. **(Do not remove the bottom bolt completely, or the control arm will drop, and the spring will violently decompress.)**

4. Your new camber bolt has a cam lobe that pushes the top of the spindle toward or away from the strut. To correct for the usual negative camber, we want it to push the top of the spindle AWAY from the strut, as shown in the above photo.

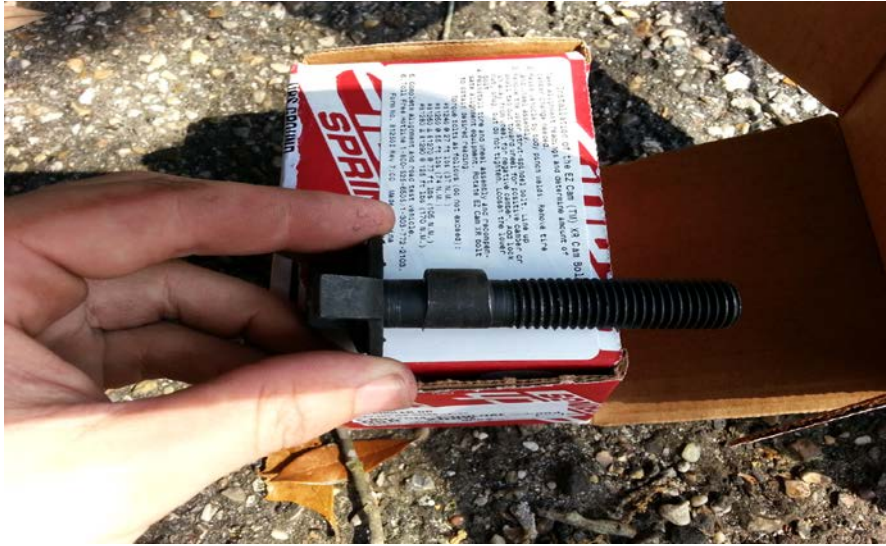
5. Slide the new bolt into the top bolt hole, and rotate it until the cam lobe has the top part of the spindle pushed away from the strut.
6. Align the stamped washer so that the 45° tab is pointed toward the spindle, and tap this gently in place until it is flush.

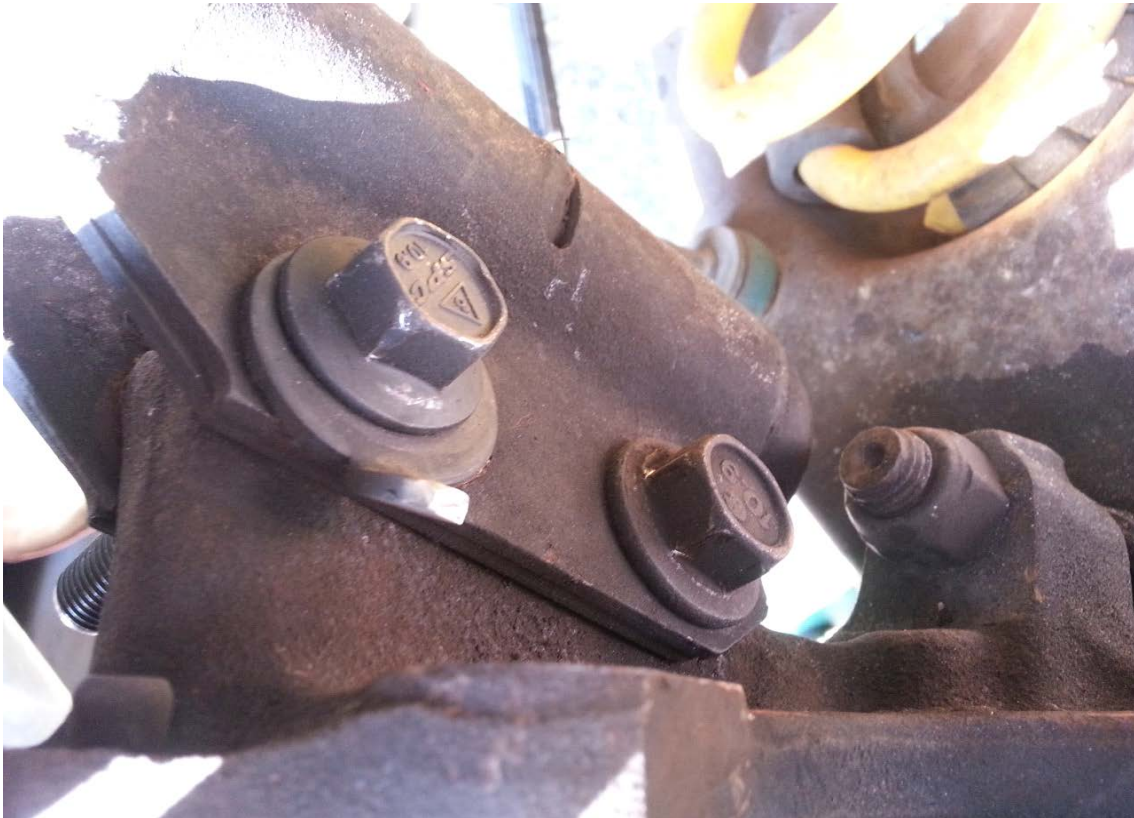
7. With a breaker bar, hold the bolt still while you thread on the lock nut. (if the bolt rotates in the hole, the cam will rotate and change the camber.)
8. Tighten the lock nut to the torque specifications listed on the box.

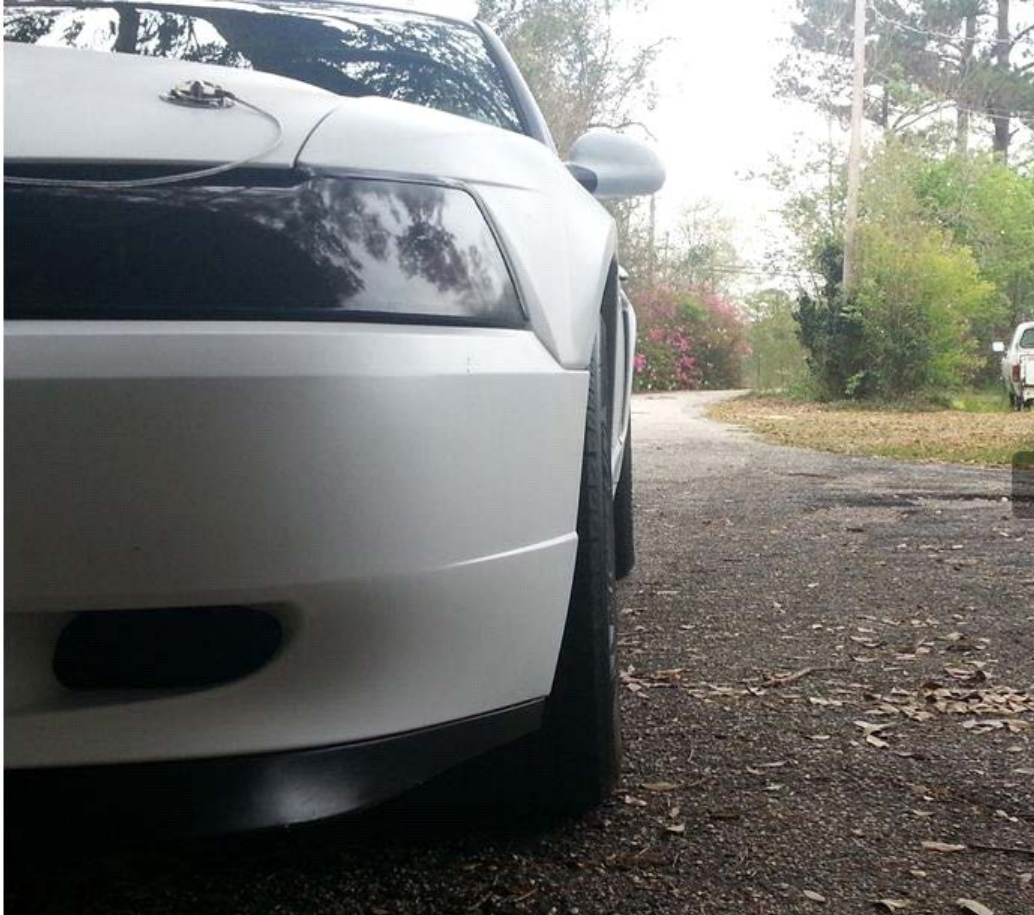
After:

Camber has been corrected so that it cannot be detected by the naked eye; however it is still wise to have your car **professionally aligned.**
