# Steeda X5 Ball Joint Installation Instructions

## 555-8108

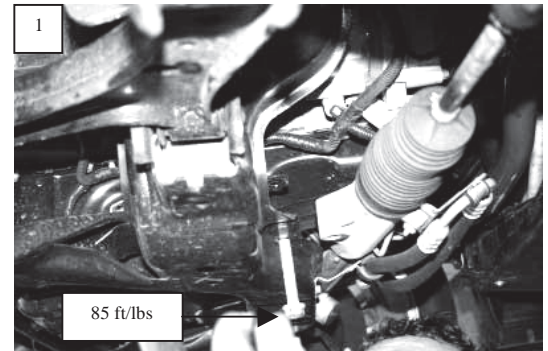
1. Raise the entire vehicle. If working from the floor, secure with jack stands. Remove the two front wheels.
2. Remove the two bolts holding the steering rack to the K-member. This will allow you to move the steering rack and gain access to the front control arm bushing. (Pic. 1)

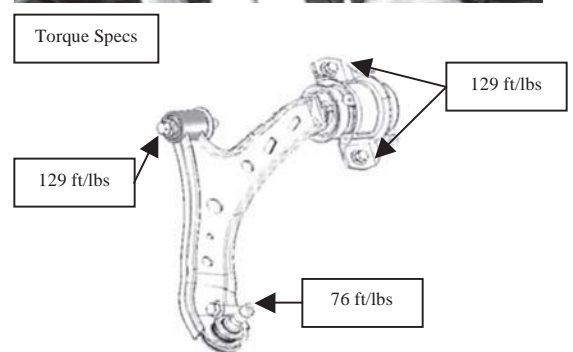
4. Once all bolts are removed, remove the front control arm. Note: It may be necessary to use a pry bar to release the ball joint stud from the clamp. (Pic. 2)
