P/N S197-525-07

2007-08 Tru-Billet Climate Control Knob Installation Instructions

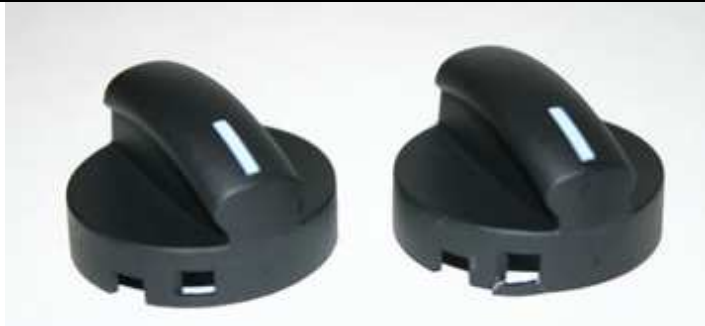
1. With the vehicle off, in park or neutral and with the parking brake set on a flat, level surface, begin by turning all three controls to the 12 o'clock position. Grasp the knobs firmly one at a time with pliers, and pull straight away from the head unit, being careful to not dislodge the shifter or accidentally release the emergency brake. This will break the outer half of the knob away from the inner half, and does require some force. Slight wiggling from left to right may aid in removal. Discard the outer half of the knob after inspecting to see how much plastic remained in the climate control unit. Look at image below to see a broken knob vs. unbroken to see where the breaks will occur. Broken piece is on the right.

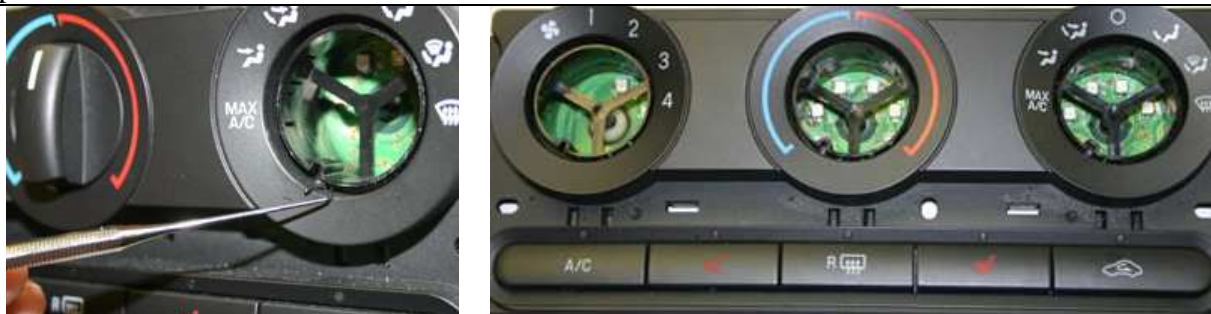
2. After removal, shine flashlight into the climate control unit, and using a small pick tool, remove any broken remnants of the outer half of the original control knobs. Looking at each knob will tell you how many pieces you must find in each hole between the inner half of the knob and the climate control housing face. When you are sure you have removed all remnants, you may want to use a small vacuum to double check your work and clear out any remaining plastic bits that were unseen.

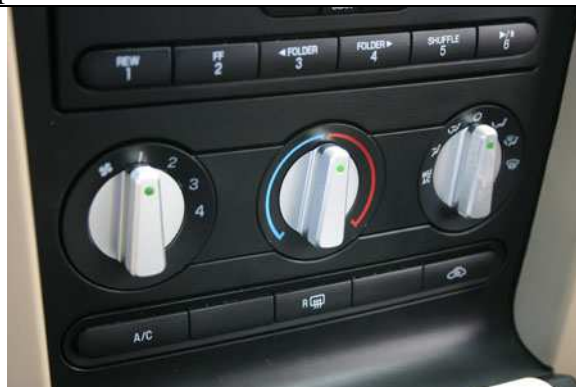
3. Install new knobs, aligning index mark (small line engraved onto diameter of knob back ring) with index mark on knob receiving half in head unit, which should be set to the 7 o'clock position to correspond to the knob being at 12 o'clock. Push firmly until you hear an audible click, or until knob surface is flush with climate control face and rotating freely like original knobs. Test for proper operation.

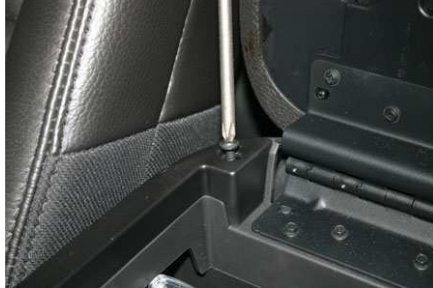
2. Open the center console armrest pad, and locate / remove the two Phillips head screws that retain the upper half of the center console to the lower half. If anything remains in the cup holder, now would be a good time to remove it.

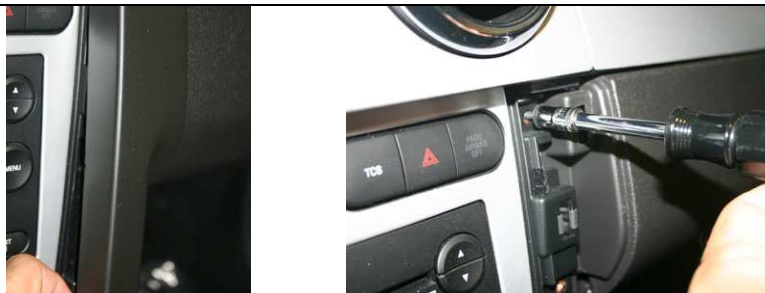
5. With the upper console removed, the two side covers / inner kick panel covers of the center dash can be removed. To remove, pull them straight away from the dash one at a time. This will expose six screws underneath, three on each side which can then be removed with a 7mm socket.

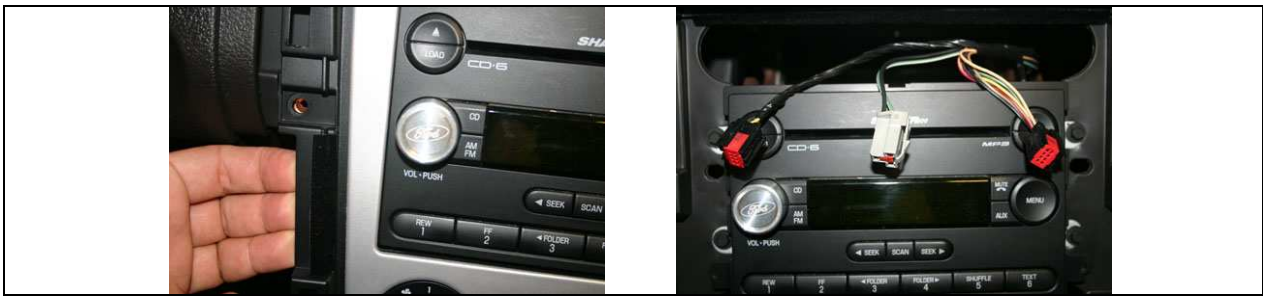
6. Once the six screws have been removed, the stereo & A/C control cover can be removed. To do so, gently pull on the sides of the cover to release the pop clips. Without removing completely, reach around the backside, and release the wiring that goes to the traction control, auxiliary power outlet (cigarette lighter) and the MyColor dash (if equipped). Once the wiring is removed, the center dash cover can be safely removed. The wiring going to the airbag light setup is one of the reasons the battery must be disconnected in step 1.

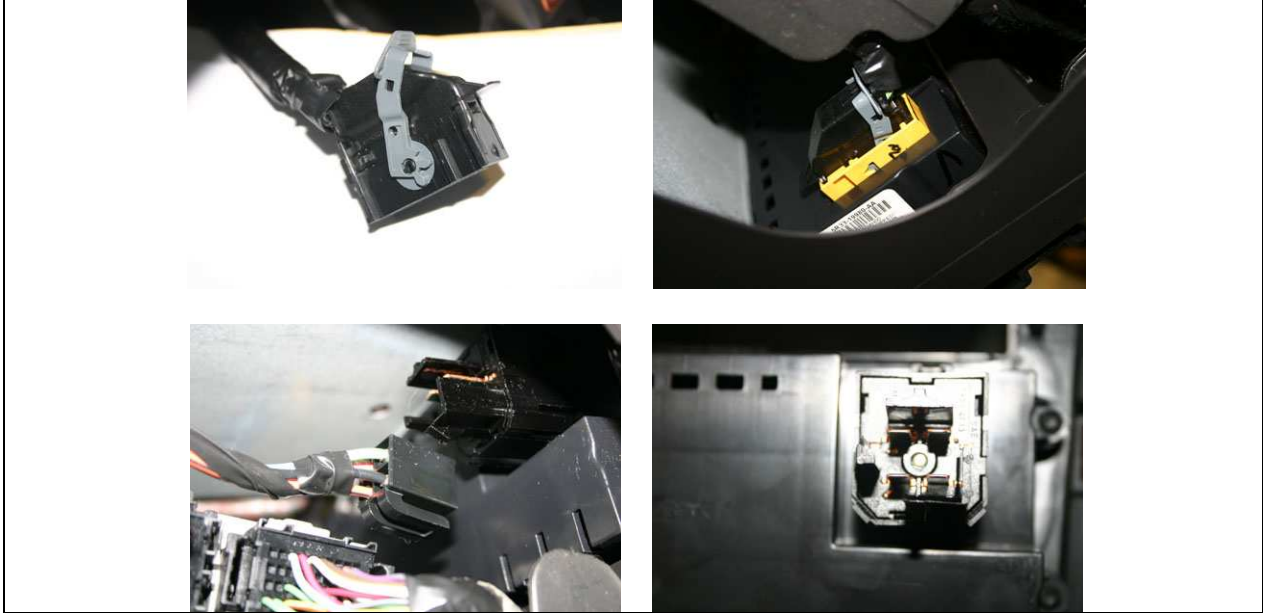
7. With the center kick panel covers removed, there will be access to the wiring to the A/C control unit from each footwell area from the backside. Reaching behind the A/C control, the fan control wiring and the additional wiring control needs to be removed. The fan control is a squeeze and release type plug, while the remaining plug is retained with a pivoting latch mechanism. Once both plugs are disconnected, the screws holding the A/C control can be removed, and the A/C head unit removed from the vehicle.

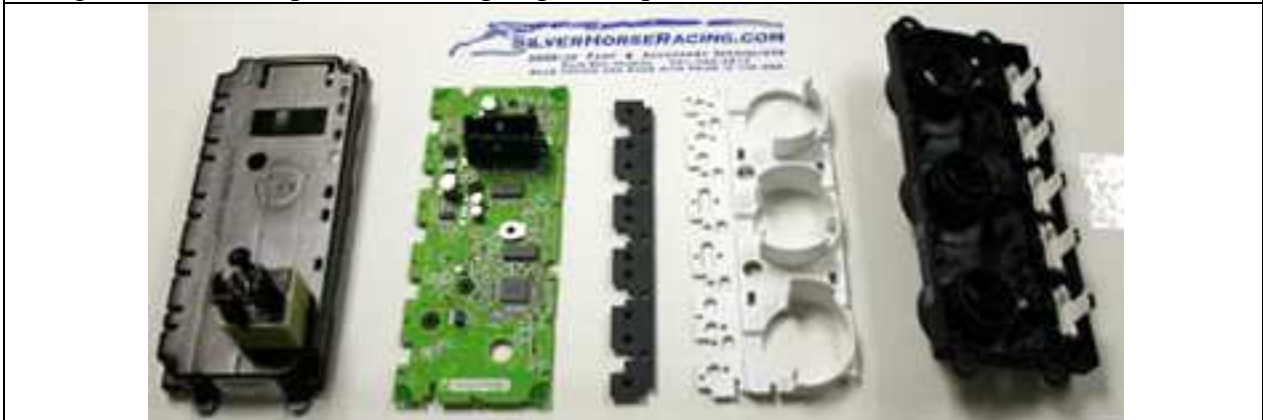
8. On a clean workbench, use the supplied T-9 Torx bit to disassemble the head unit by unscrewing the six T-9 screws. Be careful to lay out the head unit components so that they can be reassembled in the same order after the new knobs have been installed. All knobs should be in the 12 o'clock position before disassembly. Remove the back cover, carefully remove the circuit board by handling on its edges, remove the button soft panel, and the white plastic plate, being careful to unclip the small snap clips as required.

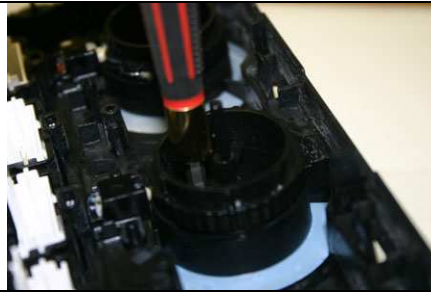
9. The front half of the knob can now be unsnapped from the balk half. All three forward halves are the same, it is the balk half which is individual to the position / function, so be sure to keep them in order or do this one knob at a time. Normally, removal of the front half of the knob will crack it at the retaining clip, as they were not meant to be a maintenance (i.e. able to be disassembled) item. This will not harm the back half of the knob if done correctly. Using a small punch, impact the outer half of the knob from the backside to break it away from the back half. Do this one knob at a time. Be careful to not damage the back half of the knob assembly,

as it will be re-used in the coming steps.

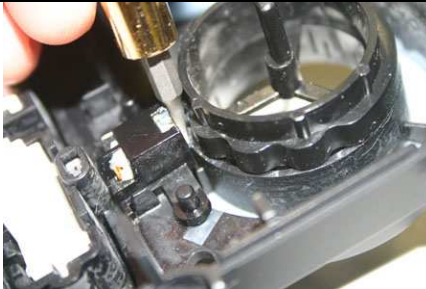
10. Using a small pick or screwdriver, depress the white ratcheting stop on the bottom of the back half of the knob to remove from the front of the control unit. There are clips retaining the 3-pronged back-half in the hole, so the will need to be wiggled out. Once removed, use a small cloth to wipe out any plastic left by the original knob, and re-assemble the back half to the face of the climate control unit, insuring it is in the same location (rotation) as when removed. If unsure, rotate the half until the index mark on the back half is in the 7 o'clock position. This would correspond to the knob being in the "up" or 12 o'clock position.

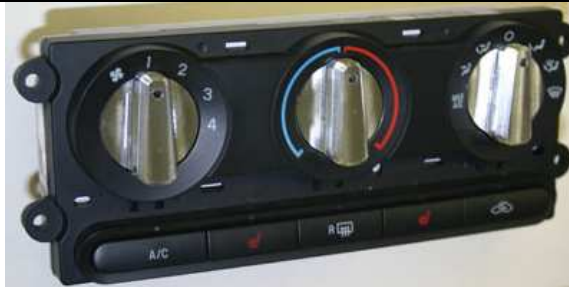
12. Install the new knobs, making sure they fully engage the back half of the knob assembly and snap into place. There is an index mark machined into the knob to correspond to the index mark on the back half of the assembly to aid in assembly – it is a small line, not completely cut through the back ring area. Check for free rotation throughout their intended range of motion, and then return them to the 12 o'clock position for re-assembly.
